SERVICE BULLETIN

Subject: Transfer Seat Base
Applicable Products: R12XX Series Products
Affectivity: All units with date codes between January 2006 and May 14, 2007

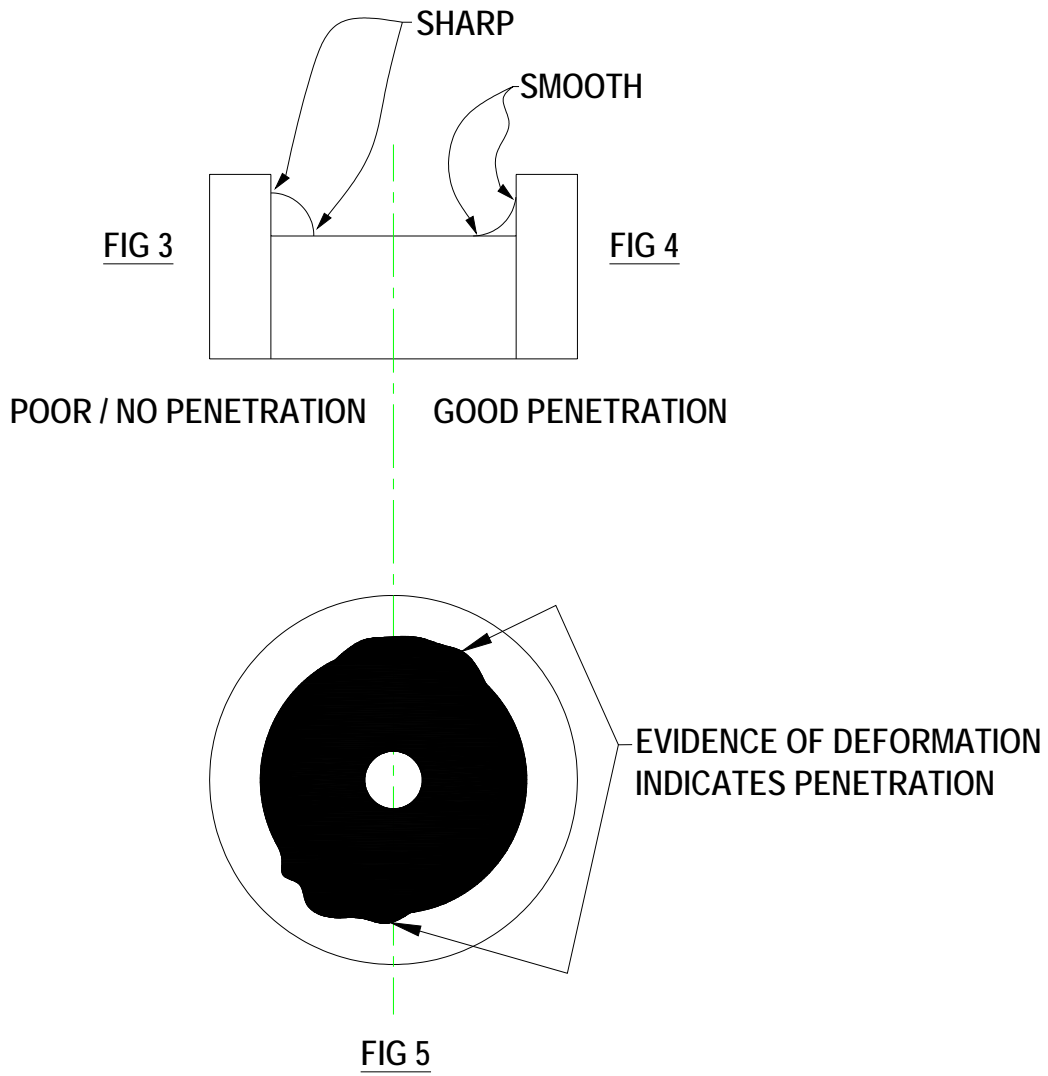
1. Sharp transitions between the fillet and the parent metal are indicative of poor penetration. Refer to Figure 3.
2. Smooth transitions between the fillet and the parent metal indicative of a good penetration. Refer to Figure. 4.
3. Deformation of the inside diameter of the bushing indicate areas of good penetration. Refer to Figure. 5.

For units that do not meet the above criteria, replace the swivel plate.
