SERVICE BULLETIN

Subject: Drive Sprocket – F9T and F9TF Series, Mirage® wheelchair lifts
Applicable Products: Ricon Part Number F9-0450
Effectivity: 01/04/2014

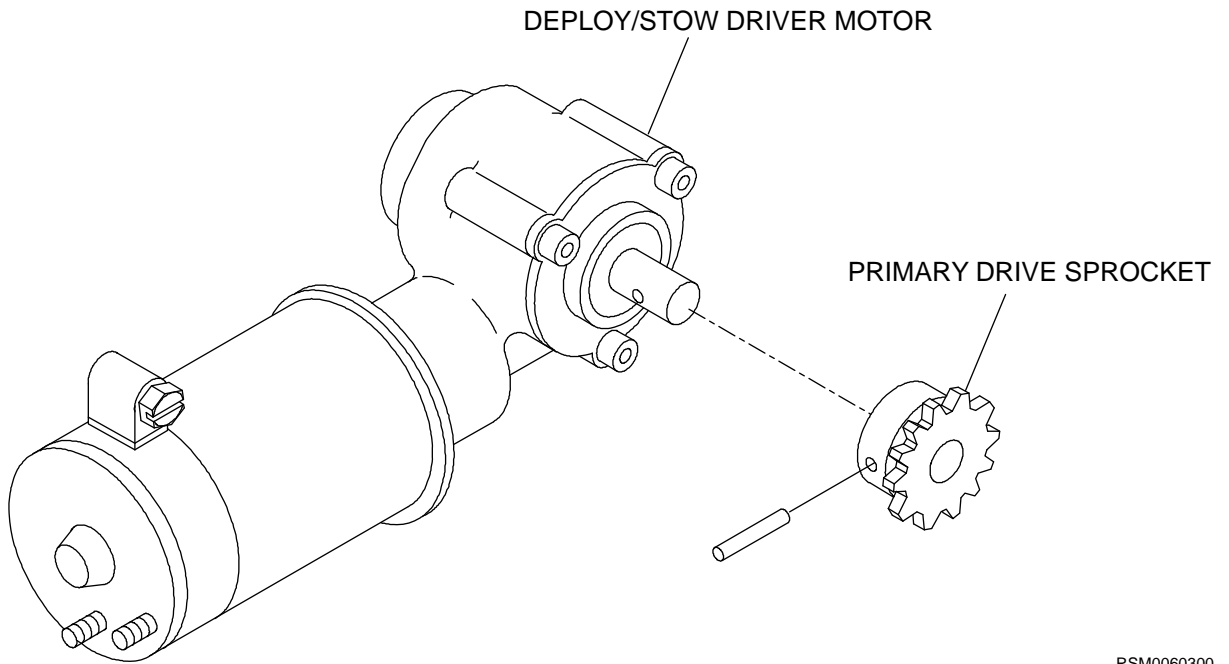
The primary drive sprocket (PN F9-0450) used on the deploy/stow drive motor (see figure 1) in the above referenced range of lifts may fail prematurely causing the motor to spin upon activation of the “Deploy” or “Stow” functions on the hand control but no movement in or out of the lift cassette resulting in the need to manually stow the lift.

Figure 1 – Primary drive sprocket used on the deploy/stow drive motor

Replace the drive sprocket

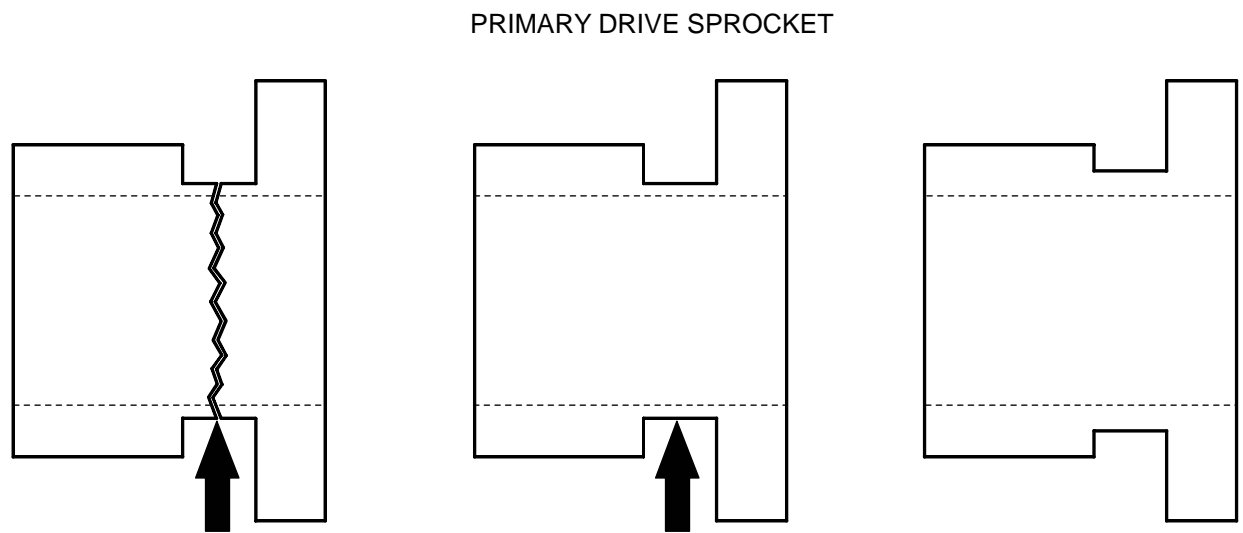
The sprocket PN F9-0450 used in the above referenced range of lifts may have included an under-cut that is deeper than the maximum permitted (see figure 2). In the event the under-cut is too deep, the remaining material available at the cross section may be too thin to support the applied load.

BROKEN DRIVE SPROCKET

THIN DRIVE SPROCKET

Figure 2 – Sprocket under-cut too deep
