SERVICE BULLETIN

Subject: Transfer Seat Base
Applicable Products: R12XX Series Products
Affectivity: All units with date codes between January 2006 and May 14, 2007

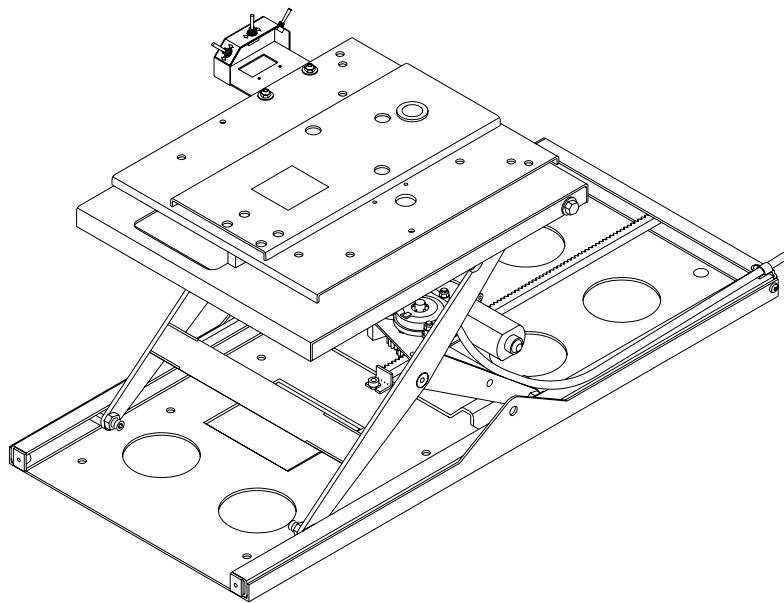
FIG. 1

Units have been found wherein the weld that retains the main pivot shaft of the 6-Way Power transfer seat base (Figure 1) has failed, allowing the pivot shaft to fall out of the seat base. Figure 2 illustrates the swivel plate assembly and the defective weld location. Defective welds of this nature may have occurred on up to 770 units made during the above mentioned date range.

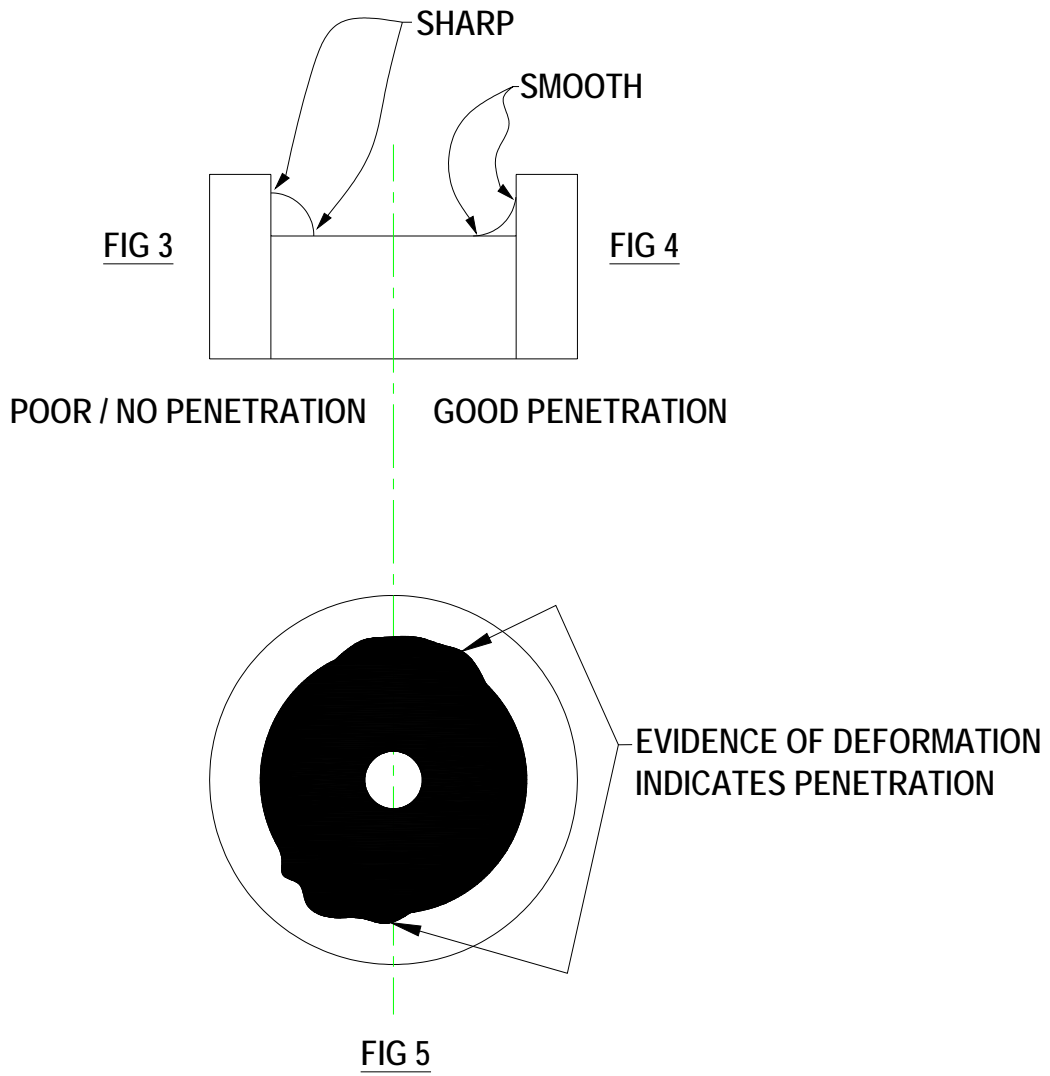
1. Sharp transitions between the fillet and the parent metal are indicative of poor penetration. Refer to Figure 3.
2. Smooth transitions between the fillet and the parent metal indicative of a good penetration. Refer to Figure. 4.
3. Deformation of the inside diameter of the bushing indicate areas of good penetration. Refer to Figure. 5.
