SERVICE BULLETIN

Subject: Inappropriate Actuation of Platform Stow Switch
Applicable Products: F9T Mirage for Metra
Effectivity: All F9T-NP002 models installed in Metra Gallery rail cars

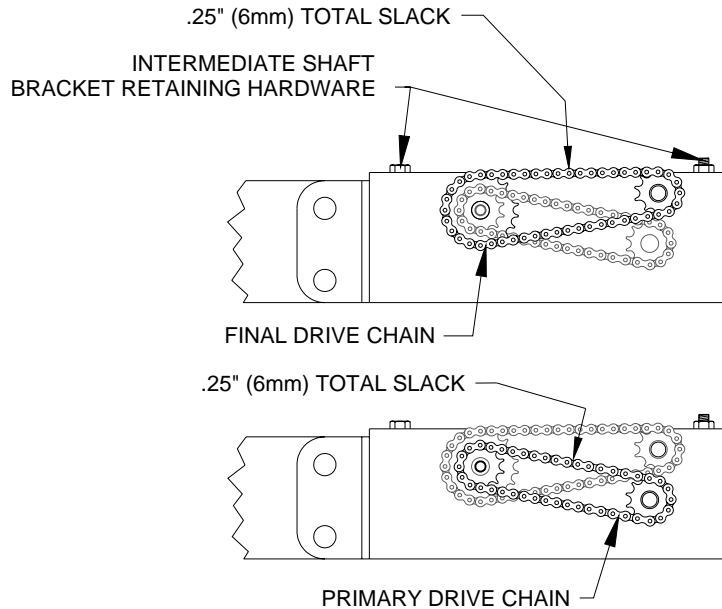
**FIGURE 2**

If there is excessive slack in the carriage drive chains the carriage will be able to move a small distance back-and-forth along the gear racks. This small movement can be enough to allow the stow switch to change state.

1. Refer to **Figure 2**. Check the slack of both drive chains; neither chain should exceed .25" deflection when pushed firmly where shown. Proceed to next step if slack is excessive.

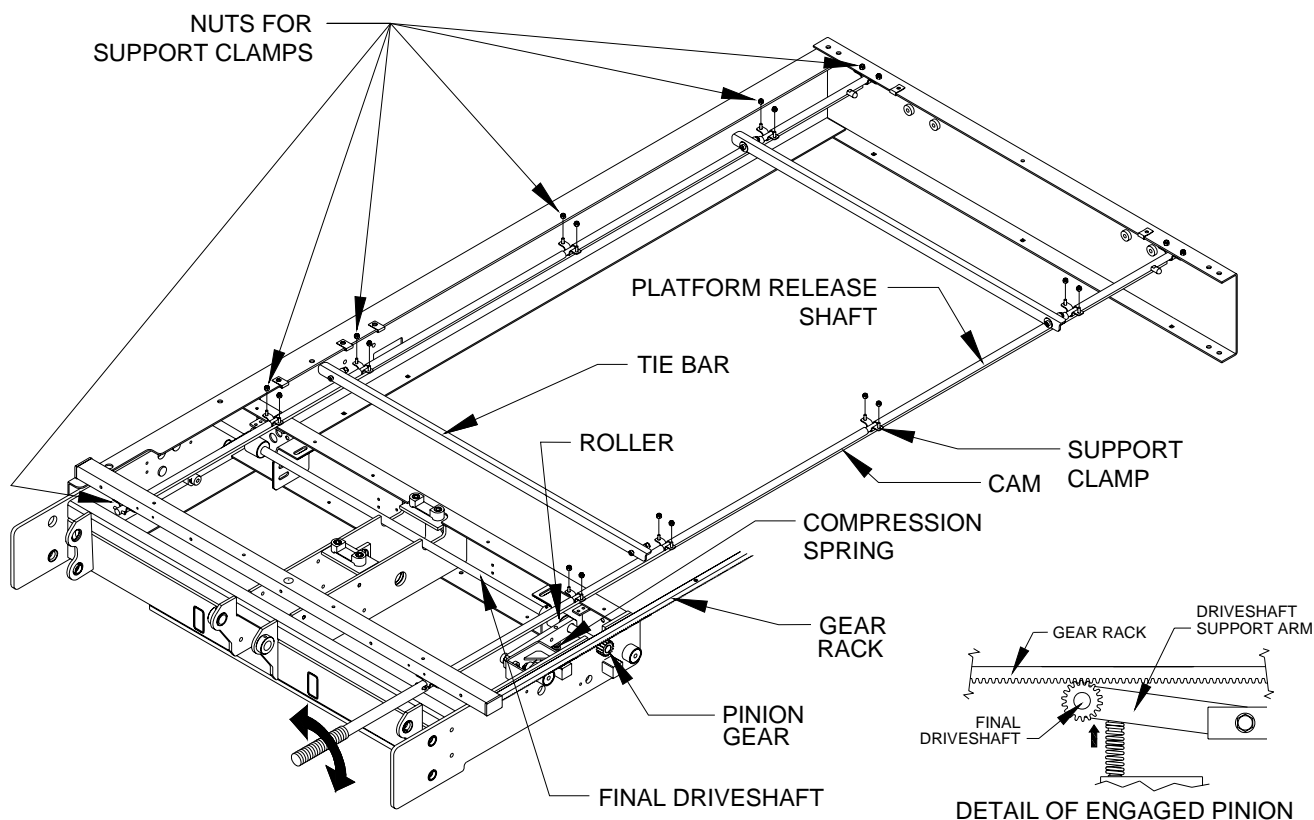
FIGURE 4

Refer to **Figure 4**. In the normal operation mode the pinion gears at each end of the final driveshaft are held engaged with the two gear racks by compression springs located near each pinion. The pinions are disengaged by rotating either of the cam-shaped platform release shafts counter-clockwise. When a release shaft is rotated it bears against a roller on the final driveshaft and deflects the driveshaft downward.

NOTE: The rotating motion of one release shaft is transferred to the other shaft through the tie bars. If either of the platform release shafts is binding in its support clamps it could prevent the springs from pushing the pinions into engagement with the gear racks.

1. Rotate each platform release shaft counterclockwise and then clockwise. Note whether the pinions fully engage the gear racks (when shafts are rotated CW) and examine the cam portion of the release shafts to see that they are not bearing against the rollers on the final driveshaft.
2. If the cam portion of either release shaft is applying pressure against its roller on the driveshaft then loosen the six pairs of support clamp nuts on the topside of the enclosure covers; these nuts secure the six clamps that support the platform release shaft.

3. Slowly retighten the nuts while rotating the release shaft. This will result in the clamps aligning themselves around the release shaft. Verify that the cam portion of the release shaft is not bearing against the roller on the final driveshaft.
4. Repeat for other release shaft, if necessary.
