SERVICE BULLETIN

Subject: S-Series and K-Series Vertical Arm Set Screws
Applicable Products: S-Series and K-Series
Effectivity: All units manufactured on May 7, 2009; June 1, 2009; June 4, 2009

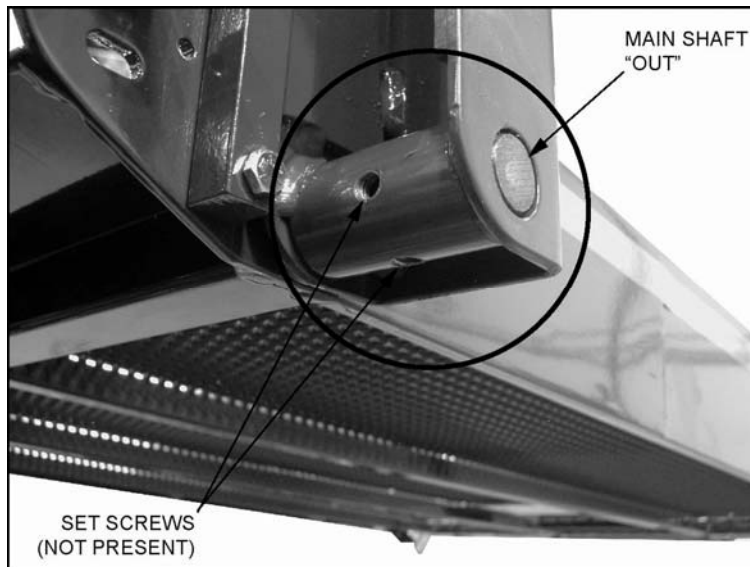
One S-Series and K-Series model manufactured on effective dates (May 7, 2009; June 1, 2009; June 4, 2009) were found to be missing set screws which can cause main shaft to separate from vertical arm, as shown in Figure 1 and Figure 2. Set screws with pre-applied medium strength thread lock must be installed to secure main shaft with vertical arm, as shown in Figure 3.

Figure 1: Main Shaft "Out" (Not Correct)

General inspection of units to ensure that set screws are present and to ensure main shaft is flush on both sides of platform. Contact Ricon for any required parts.

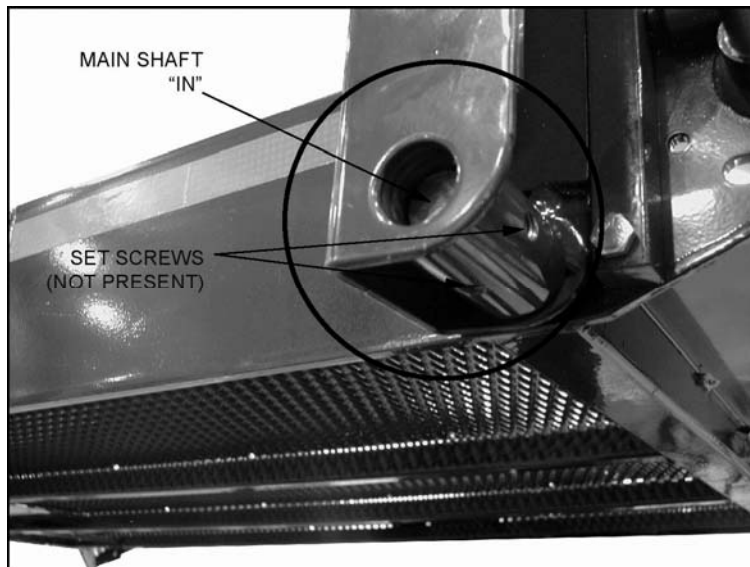
Figure 2: Main Shaft "In" (Not Correct)

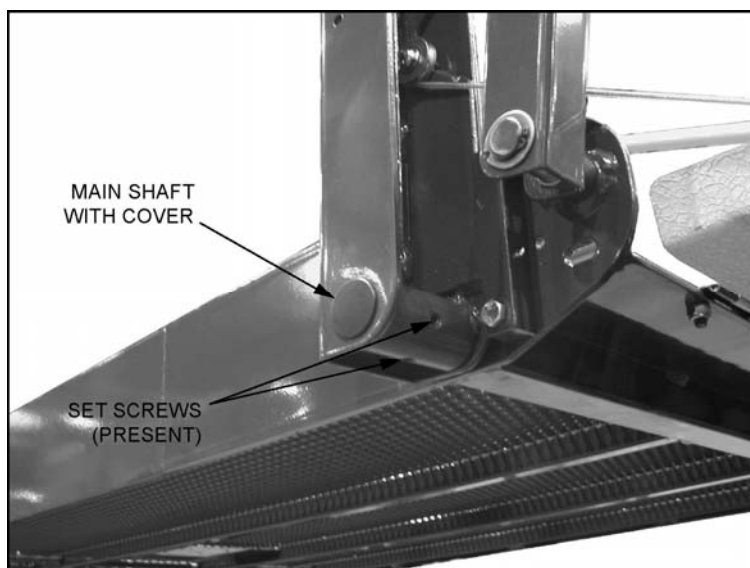
Figure 3: Correct Set Screw Installation

Vertical arm set screws with pre-applied tab of medium strength thread lock are required.

1. Deploy platform to floor level.
2. Refer to Figure 3. Install two set screws to secure main shaft. Torque set screws to 15ft.lbs. Repeat for opposite side.
