SERVICE BULLETIN

Subject: FR2G-Series Ramp Deutsch Connector
Applicable Products: **FR2G-Series Ramps**
Effectivity: All
Ricon Product Support: Phone: 1-800-322-2884
Email: customerservice@riconcorp.com

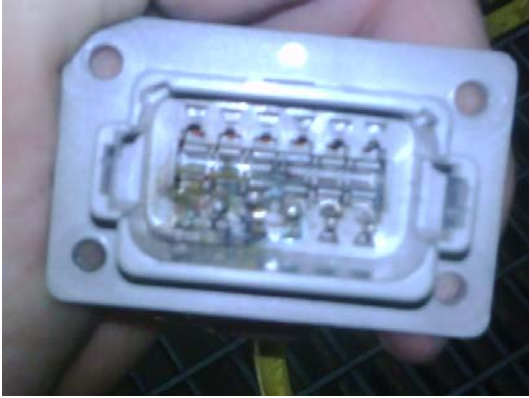
FR2G-Series Ramp products have been found wherein the Deutsch connectors and/or terminals could potentially contain corrosion where the harness connects to the back of the ramp, due to moisture. The corrosion of the Deutsch connector terminals may provide continuity in the wiring which could potentially create discrepancies in the signals to and from the dash control panel and the ramp controller. Refer to Figures 1 and 2.

Figure 1: Deutsch Connector with Corrosion

General inspection of the Deutsch connector that connects to the back of the ramp will show if the connector contains the white Deutsch plugs installed in the empty sockets and will determine if the connector shows signs of corrosion. Refer to Figures 3, 4 and 5. If the connector shows no sign of corrosion and does not have the white Deutsch plugs installed then installation of the white Deutsch plugs (P/N 14974) is only necessary as shown in Figures 4 and 5. If any connector shows signs of corrosion then the connector and Deutsch pins should be replaced.

1. Disconnect power from the vehicle.
2. Locate and identify harness (P/N 28511 or 29620) that shows signs of corrosion on the Deutsch connector.
3. Disconnect corroded Deutsch connector.
4. Extract then strip corroded Deutsch pins from connector.
5. Install and crimp new Deutsch pins.
6. Insert new Deutsch pins with crimped wire into new Deutsch connector.
7. Reconnect harnesses.
8. Reconnect power to the vehicle.
9. Test ramp by running a few Deploy and Stow cycles to ensure ramp is working properly.

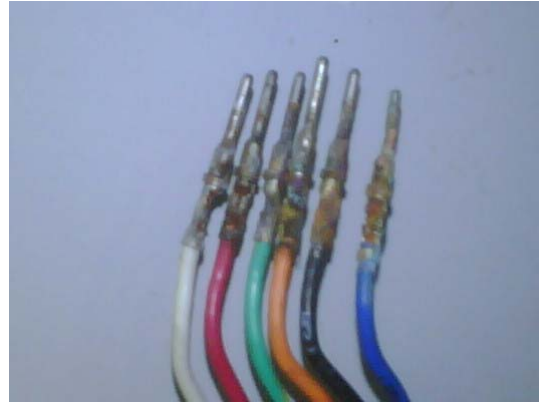
Harness with Deutsch connector terminals that do not have the white Deutsch plugs in the empty sockets may allow water to enter into the connector and corrode the terminals. Refer to Figure 2.

Figure 2: Deutsch Pins with Corrosion

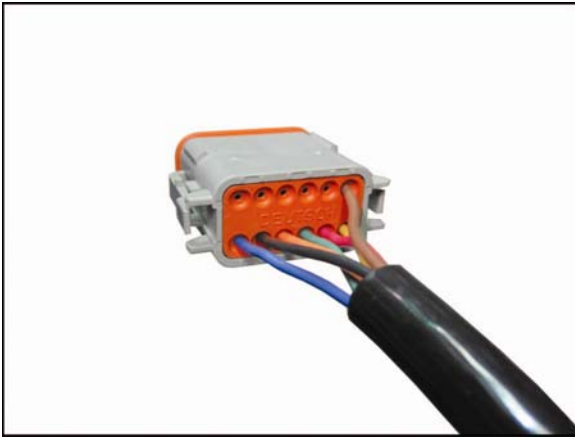
Figure 3: Deutsch Connector without Deutsch Plugs

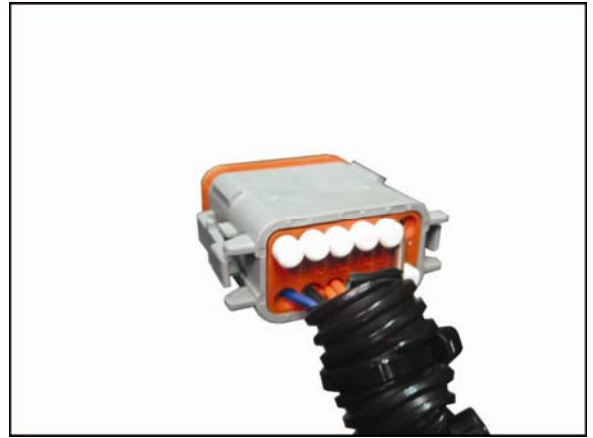
Figure 4: Deutsch Connector with Deutsch Plugs

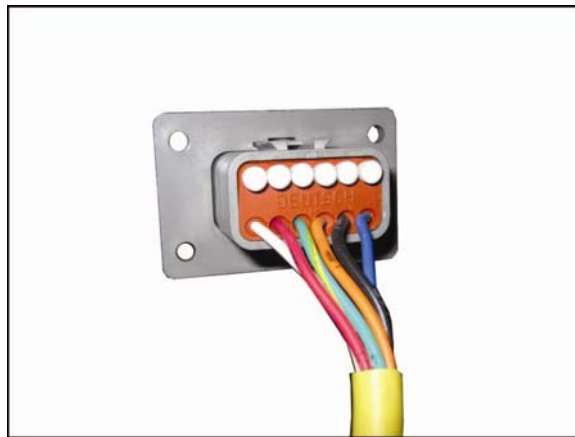
Figure 5: Deutsch Connector with Plugs
