SERVICE BULLETIN

Subject: Improper Use of Folding Ramp as a Handrail
Applicable Products: "Activan" minivan conversion
Effectivity: All – personal and commercial

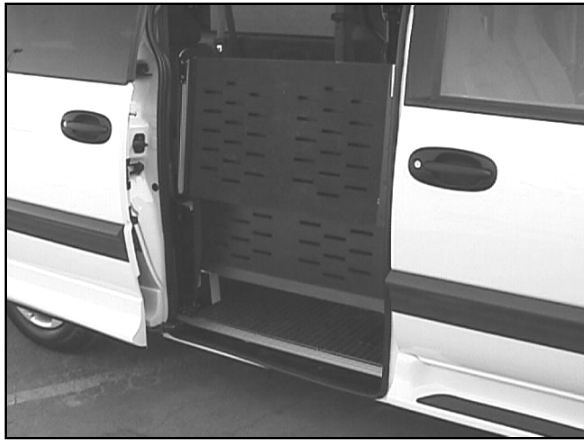
FIGURE 1

Physically impaired people enter the Activan vehicle through the side door, which is often equipped with a folding ramp. The ramp may be either a manually operated type or a powered type. When not in use, the ramp is folded and raised to a vertical position within the doorway (refer to Figure 1). When needed for entering or exiting the vehicle, the ramp is unfolded and lowered to the ground (refer to Figure 2). When an ambulatory person needs to enter or exit the vehicle at the side door, the raised ramp is swung outward like a gate (refer to Figure 3).

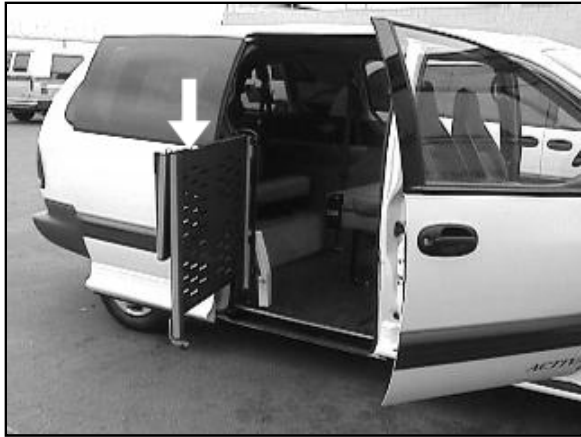
FIGURE 3

When the ramp is swung out, passengers entering or exiting are prone to using the top edge of the folded ramp as a handrail. When in this position, the ramp is not intended to support additional weight. If any force is applied along the upper edge of the ramp (refer to Figure 3), the vertical bracket supporting the ramp flexes at its lower end. This flex leads to premature fatigue and cracking. Once cracked, the bracket can fail, allowing the ramp to drop unexpectedly.

The person responsible for operation of the folding ramp (typically the vehicle operator) should watch over its use, and caution passengers against using the folded ramp as a handrail.
