SERVICE BULLETIN

Subject: NON-REFLECTIVE TAPE FOR SENSOR COVERS
Applicable Products: S AND K SERIES LIFTS
Effective Date: 03-10-06

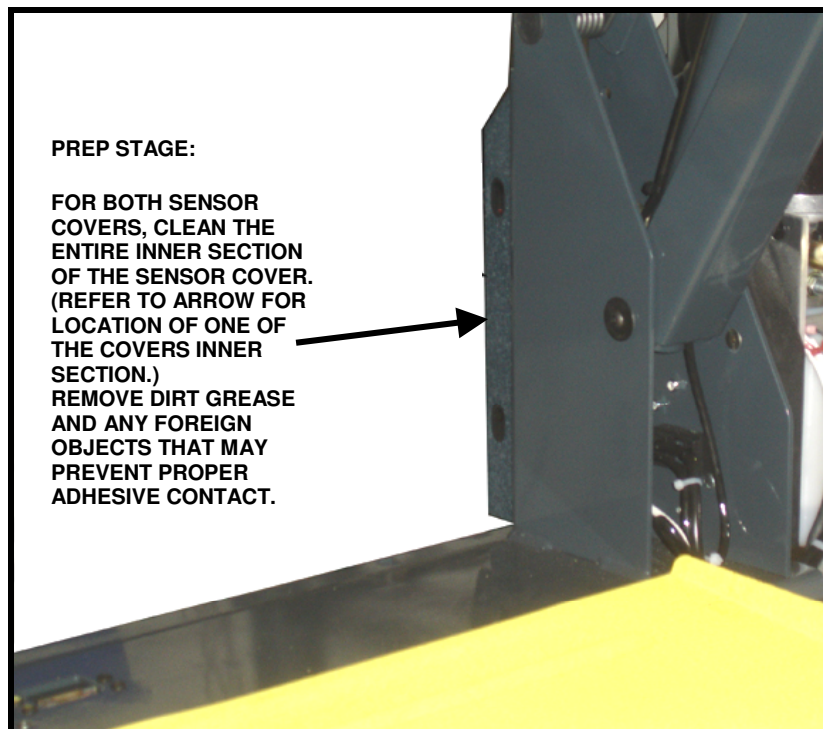
Figure [1] NON-REFLECTIVE TAPE PREP STAGE

Corrective Action: Installation Non-reflective tape.

Parts Involved: Kit # 35707. The kit can be ordered by calling 1-800-322-2884, please have lift Serial number available.

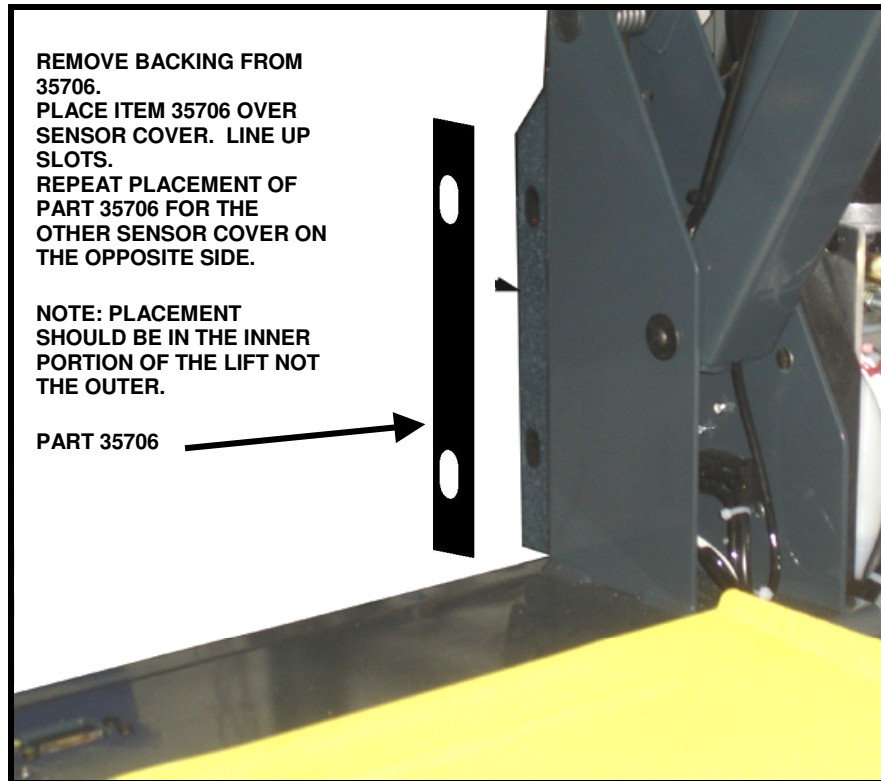
Figure [2] NON-REFLECTIVE TAPE INSTALLED
AS NOTED IN THE TEXT ABOVE THIS SHOULD BE DONE ON
BOTHSIDES OF THE LIFT. THE SECTIONS FACING THE
BRIDGE PLATE SHOULD BE THE ONLY SURFACES
REQUIRING THESE ADDITIONS.
