SERVICE BULLETIN

Subject: Hydraulic Pump Assembly
Applicable Products: S & K Series Lifts
Effectivity: 06-30-2005

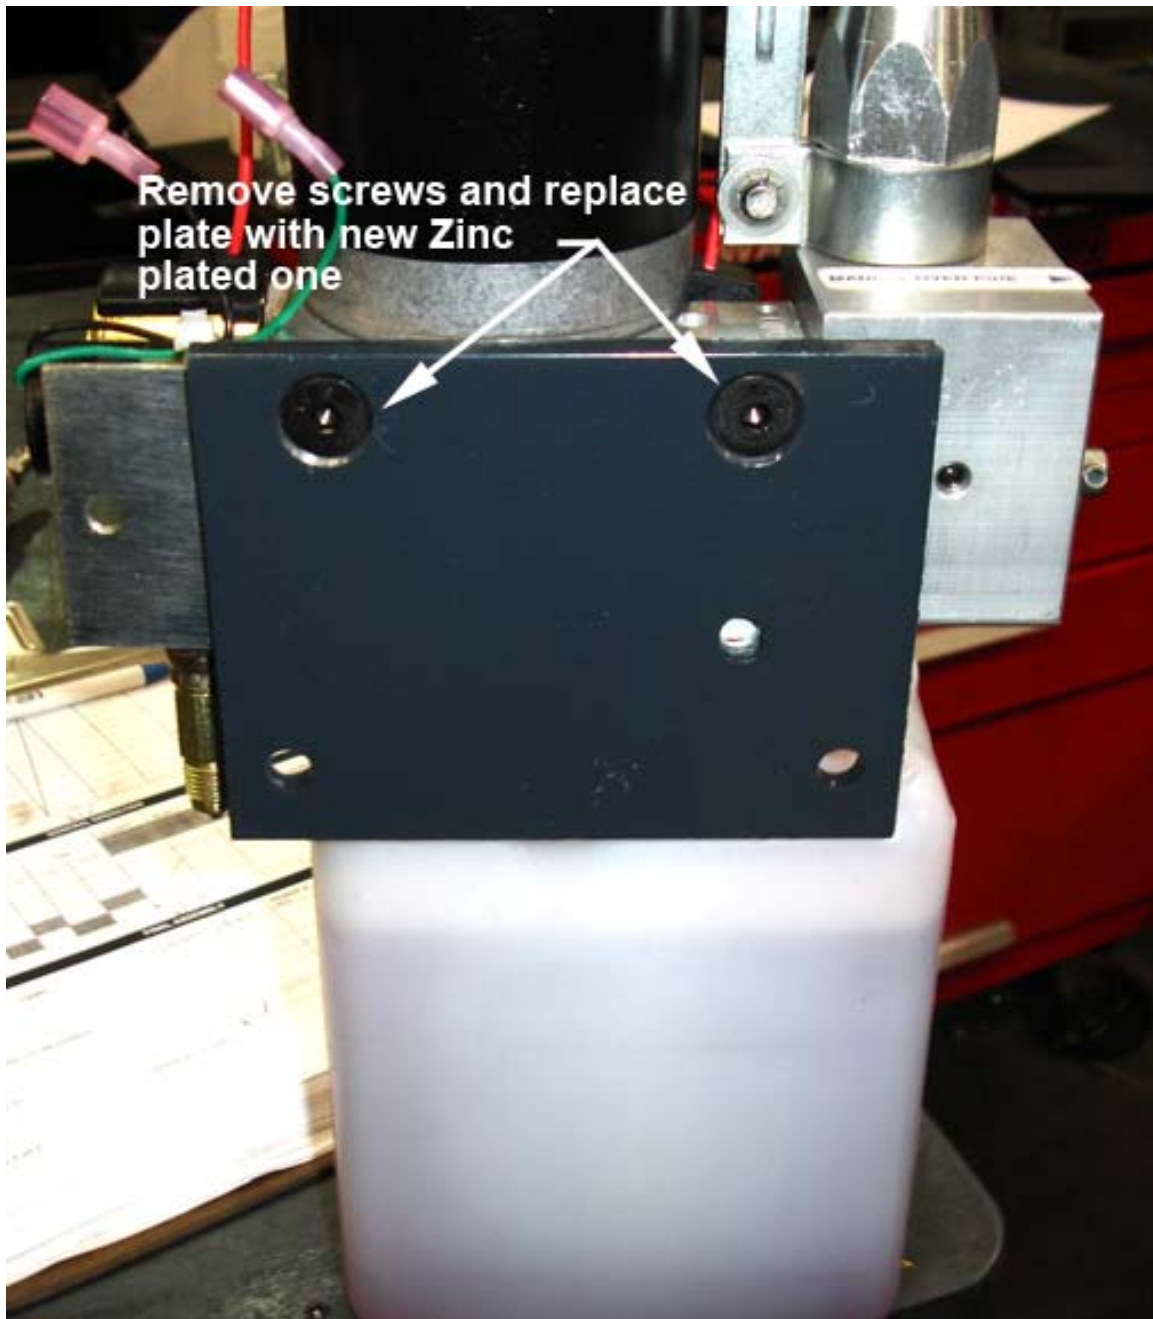
Figure [01]

Intermittent or complete electrical lift failure
Private lifts may not be able to wake interlock system after it has gone to sleep

Painted mounting plate for the S & K series lift pumps starting with Serial number 187574 and ending with 188183 manufacture dates 6-20-05 thru 6-30-05. Note: Not all of these lifts have the Painted plates, but most do.

Replace Painted Mounting Plate with Clear Zinc Plated Mounting Plate. See Figure 01.
Disconnect battery ground wire, remove pump assembly; remove Painted Mounting Plate, install new Zinc Plated Plate. Reinstall pump connect Battery and operate lift.

- After removing pump from lift, remove two countersunk screws.
- Replace with new Zinc Plated part.
- Reinstall pump. Connect Battery and test lift.
