Subject: S-Series Platforms: 34in. x 54in., 32in. x 51in.
Applicable Products: S1205, S2005, S2010, S5005, S5010, S5505, S5010
Effectivity: 6/24/2014

This bulletin provides a brief description of a technical issue related to the inspection and possible replacement of the platform assembly of certain S-Series wheelchair lifts.

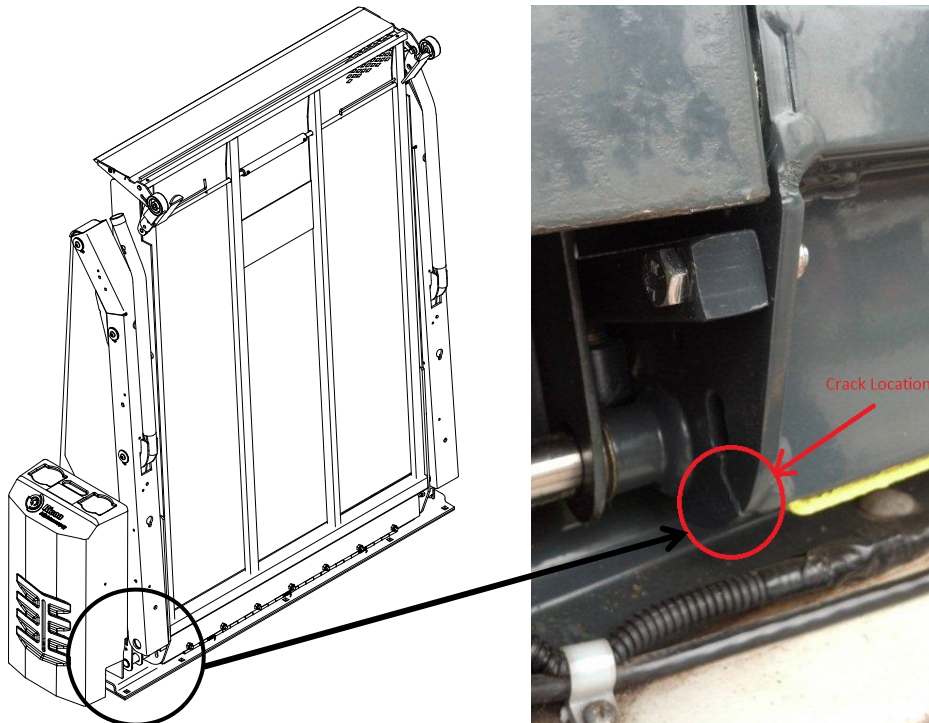
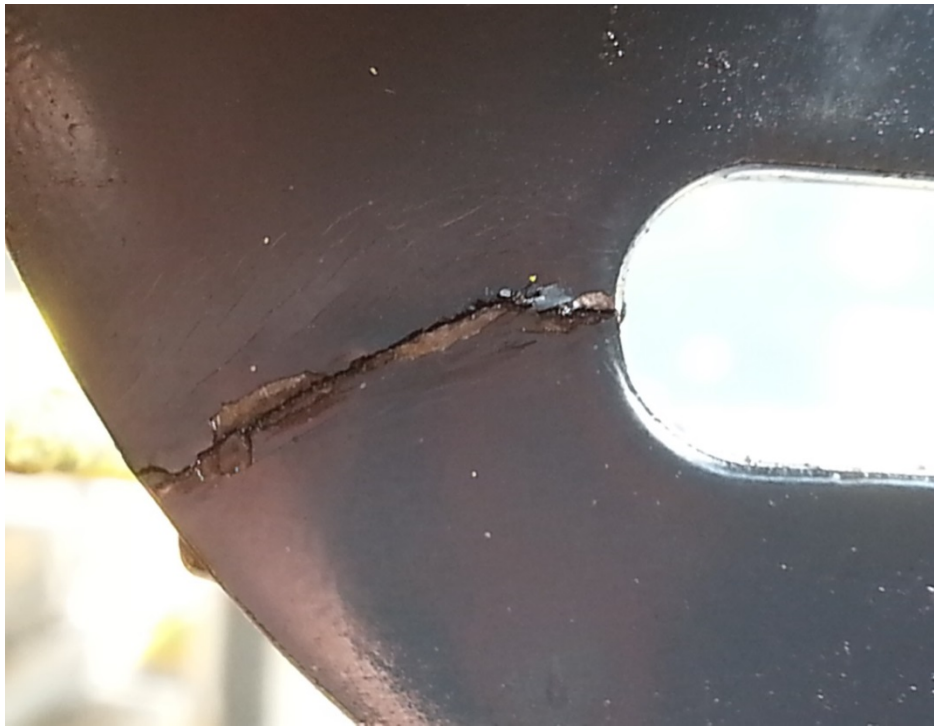
Under certain conditions the side plate of the larger platforms included on the subject S-Series model wheelchair lifts can exhibit cracking while in the stowed position which, if left unchecked can propagate to the point where separation of the rear portion of the side plate occurs rendering the lift inoperable and possibly unsafe to use.

The cracking as illustrated has been observed on less than 5% of the subject population and appears to be caused by a combination of factors including but not necessarily limited to, incomplete stowing of the lift and/or maladjustment or otherwise malfunctioning of the stow lock device combined with a violent side- to- side movement that might be associated with traversing curbs, speed bumps and other variable road conditions, especially at higher speeds.

If cracks are found, the platform must be replaced as soon as possible. Use the following part numbers for the associated model numbers.

For Models S1205-G, S1205VG	Use PN 33851
For Models S2005-S, S5005-S, S2005-T, S5005-T	Use PN V2-PF-389
For Models S2005-F, S5005-F, S2005-G, S2005-C, S2005VF, S2005-J	Use PN 32466
For Models S2005-L, S5005-L	Use PN 38330
For Models S2010-S, S2010-T, S5010-S, S5010-T	Use PN 16622
For Models S2010VF, S2010-C, S2010-F, S5010-F	Use PN 32469
For Models S5505-S	Use PN 34846
For Models S5505VF, S5505-C, S5505-F	Use PN 33485
For Models S5510VF, S5510-F, S5510C, S5510-J	Use PN 34249
